MOCLIPS RIVER CED RETROFIT

FEBRUARY 1, 2005

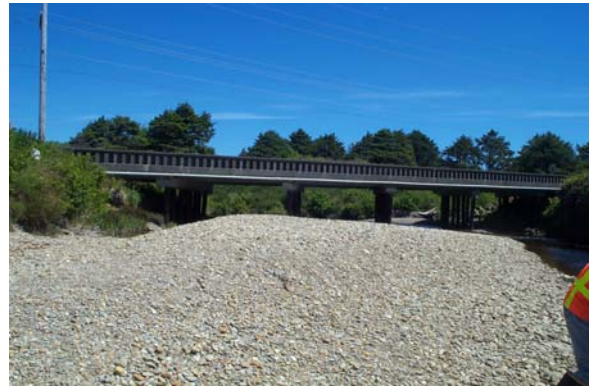
Figure 1. Moclips River CED site.

The Moclips River retrofit site is located along State Route (SR) 109 between milepost (MP) 31.54 and 31.56. This site is just south of the town of Moclips. SR 109 is a main transit route for local and tourist traffic.

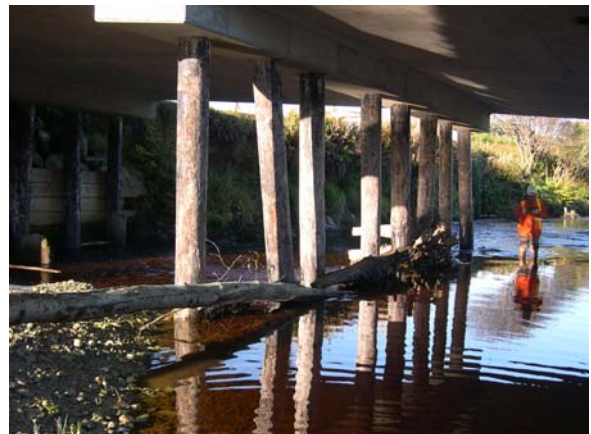
Figure 2. Detail of Moclips River, SR 109 bridge piers.

At the Moclips River Bridge, SR 109 is inundated by flooding at least once each year. These flooding events cause periodic road closures, and result in the deposition of debris both on the road and against the bridge. Moreover, woody debris accumulates on the upstream side of the bridge and rock is deposited on the downstream side, which results in restriction of the channel. This debris must be removed after the flooding to prevent further damage to the infrastructure and salmon habitat due to the restricted channel.
